FIRE TEST REPORT 13 - G- 222

According to norms EN 1363-1:2012 and EN 1364-1:1999

Test	13 - G -222
Performed on	March 20 th , 2013
Regarding	A glazed partition wall made of a steel frame
Frame	: RP ISO Hermetic 70 (RP TECHNIK)
Glazing	: 26 mm thick PYROBEL 25 (AGC)
Overall dimensions	: 4,940 x 4,960 mm (w x h)
Sponsor	RP Technik GmbH Profilsysteme Edisonstrasse 4 D - 59 199 BÖNEN

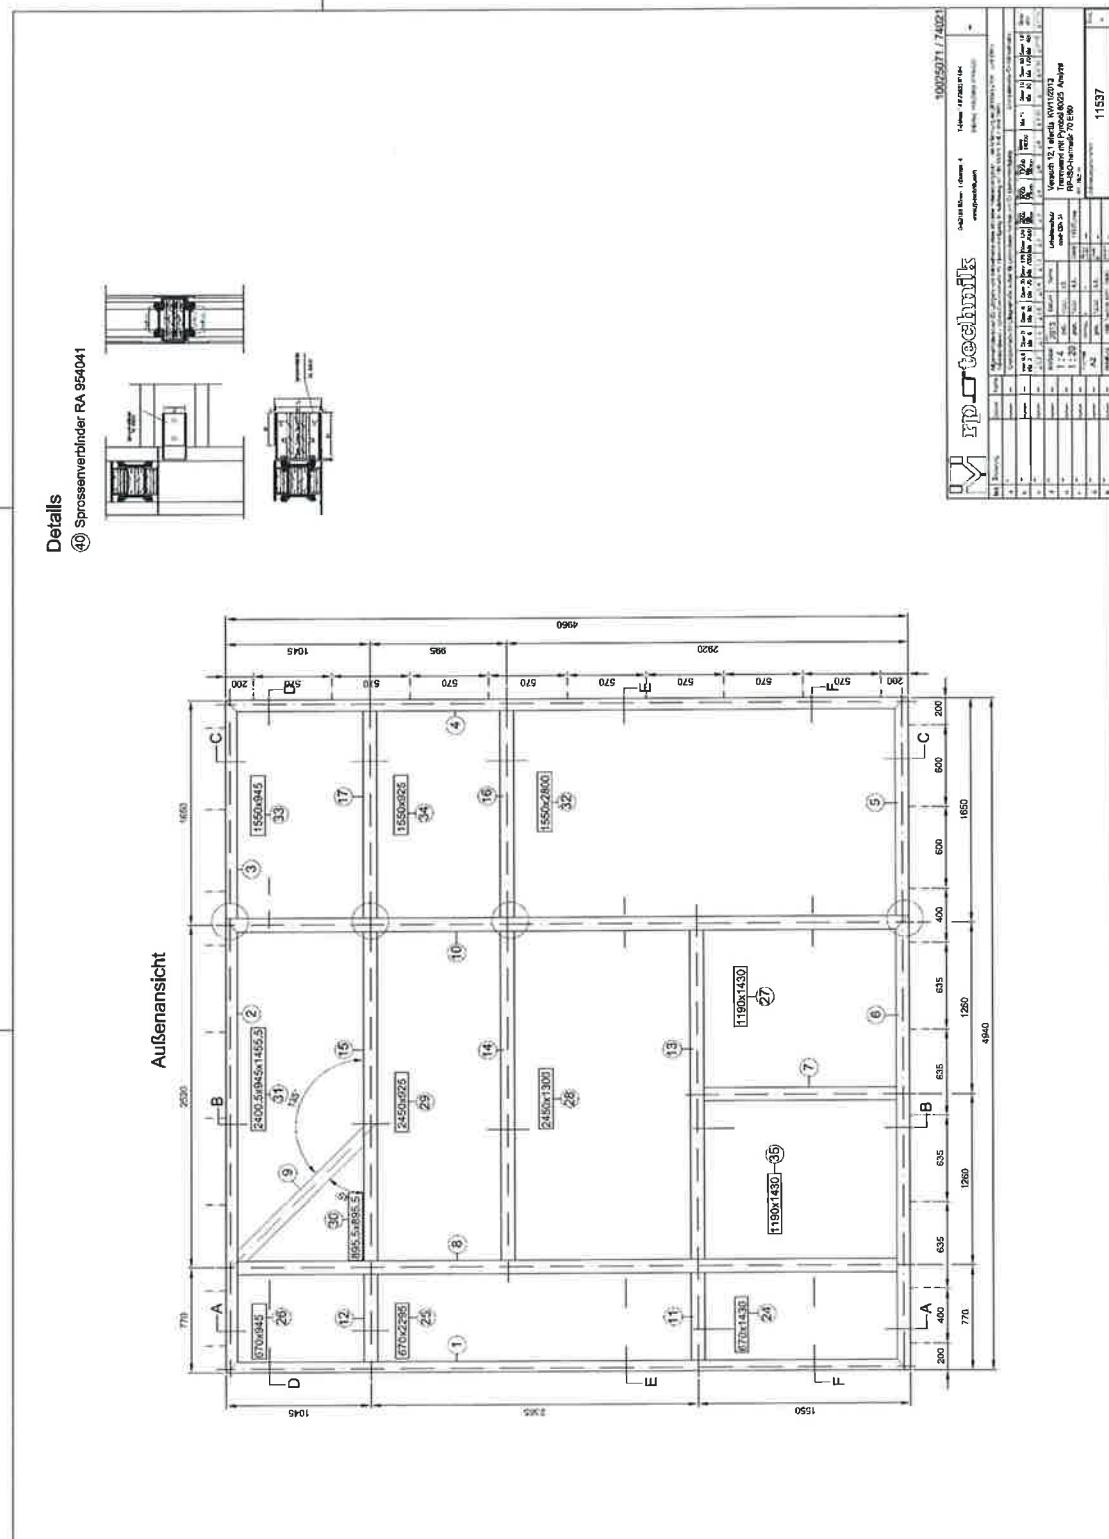
PLATE 1: OVERALL VIEW WITH DETAILS OF THE FIXATION BETWEEN THE TWO FRAMEWORKS

The intermediate profiles of the two frameworks were composed of 70 x 100 mm steel profiles, reference RPF 915212 (RP TECHNIK). These profiles were straight cut and assembled together or to the peripheral frames by welding except for the junction between the transoms of the second framework and the mullion doing the junction between the two frameworks, which was realised by connectors, reference RA 954041 (RP TECHNIK), insulated by two 15 mm thick FERMACELL plates (XELLA), fixed to the mullion by two steel screws M5 x 20 mm and to the transoms by four fixing pins Ø 5 x 20 mm. See plate nr 1.

The framework was assembled within the supporting construction by screws HUS-S Ø 6 x 180 mm (HILTI), staggered in the steel shells of the profiles as shown on plate nr 2 and located as shown on plate nr 1.

See plates nr 1 and 4.

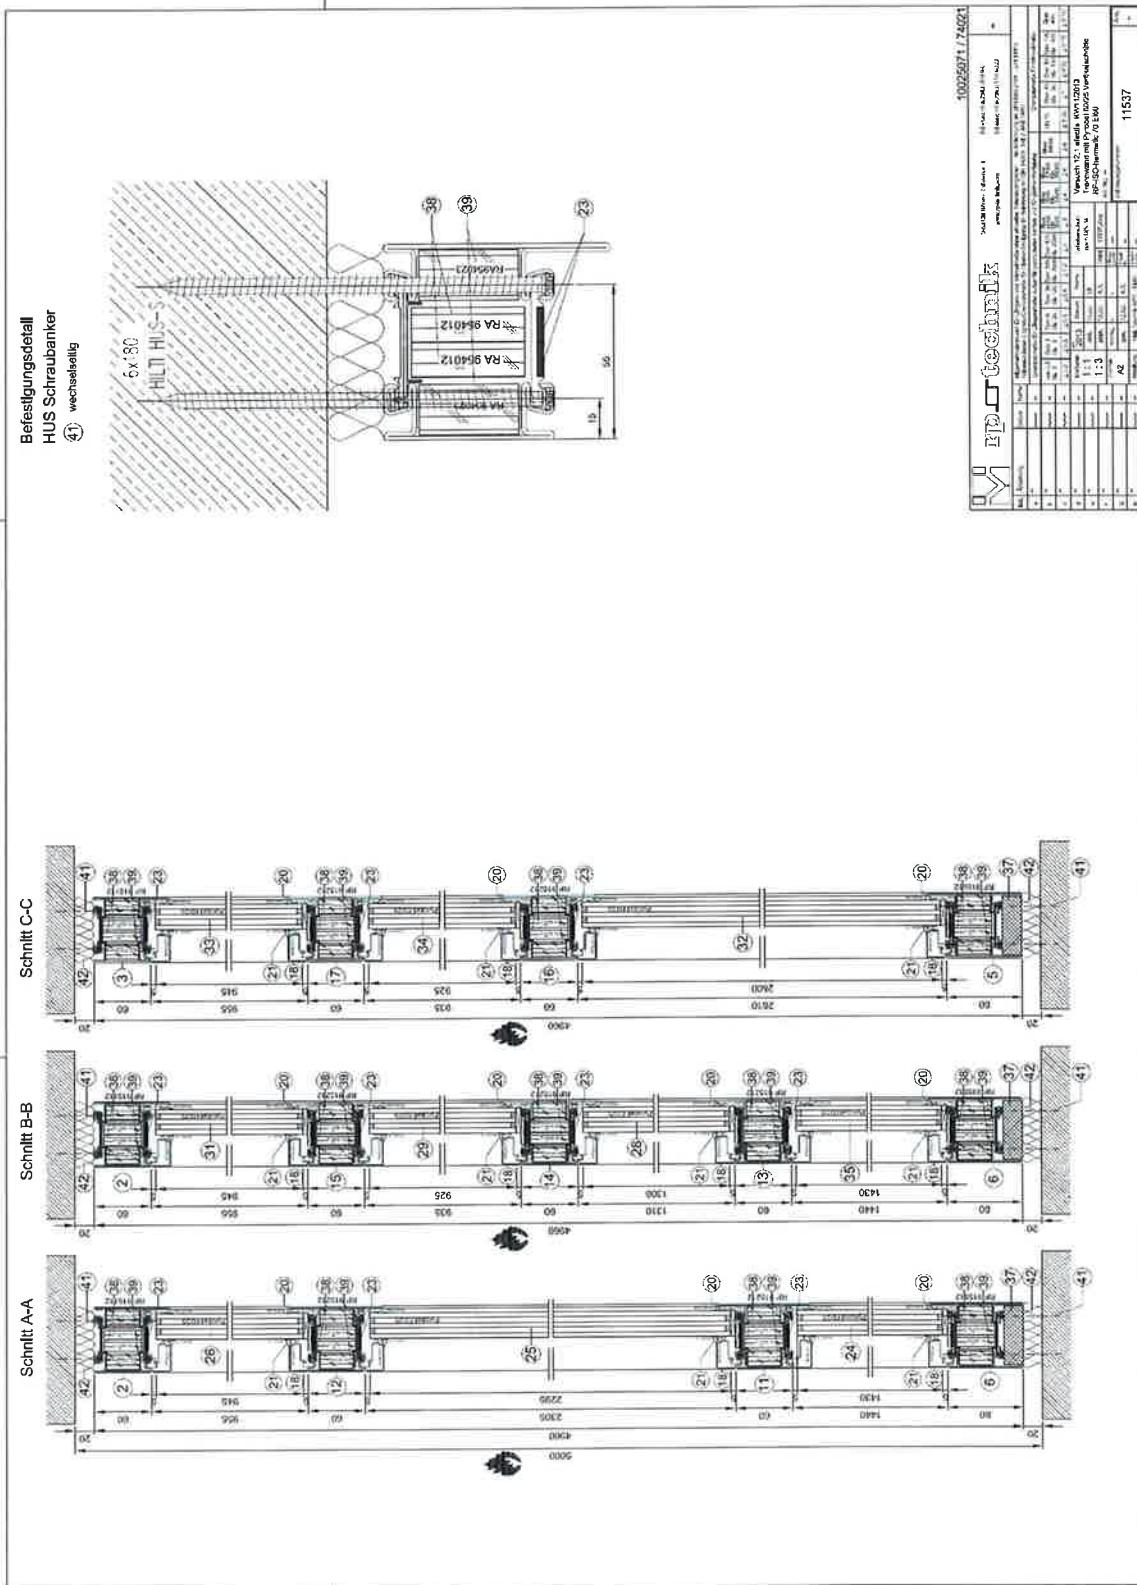
**PLATE 2: VERTICAL SECTIONS A-A, B-B AND C-C
WITH DETAILS OF THE FIXATION TO THE SUPPORTING CONSTRUCTION**

All the profiles were composed of two steel shells, each one insulated by a 18 mm thick FERMACELL plate (XELLA), and then linked together by two polyamide stiffeners. The such formed cavity was also insulated by two 12,5 mm thick FERMACELL plates (XELLA), reference 954012 (RP TECHNIK). See plates nr 2 and 3.

The bottom transoms were also insulated by a supplementary 20 mm thick Promatect-H plates layer (PROMAT) fixed on the transoms by screws Ø 4,2 x 39 mm located every 600 mm. See plate nr 2.

The gap between the framework and the supporting construction was insulated laterally by 20 mm thick mineral wool FLOORROCK TE 20 (ROCKWOOL) plates, density 55 kg/m³. See plates nr 2 and 3.

The glazing were held by a simple bead system made of steel profiles reference RP 920072 (RP TECHNIK) and section 30 x 20 mm (w x h), pushed onto the profiles of the frameworks. See plates nr 2 and 3.

The glazing beads were associated to an EPDM gasket, reference RA 930116 (RP TECHNIK) whereas the profiles were associated to an EPDM gasket, reference RA 930096 (RP TECHNIK). Two PROMASEAL LW tapes, reference RA 957235 (RP TECHNIK) and section 12 x 2 mm were implemented all around the glazing on the profiles. See plates nr 2 and 3.

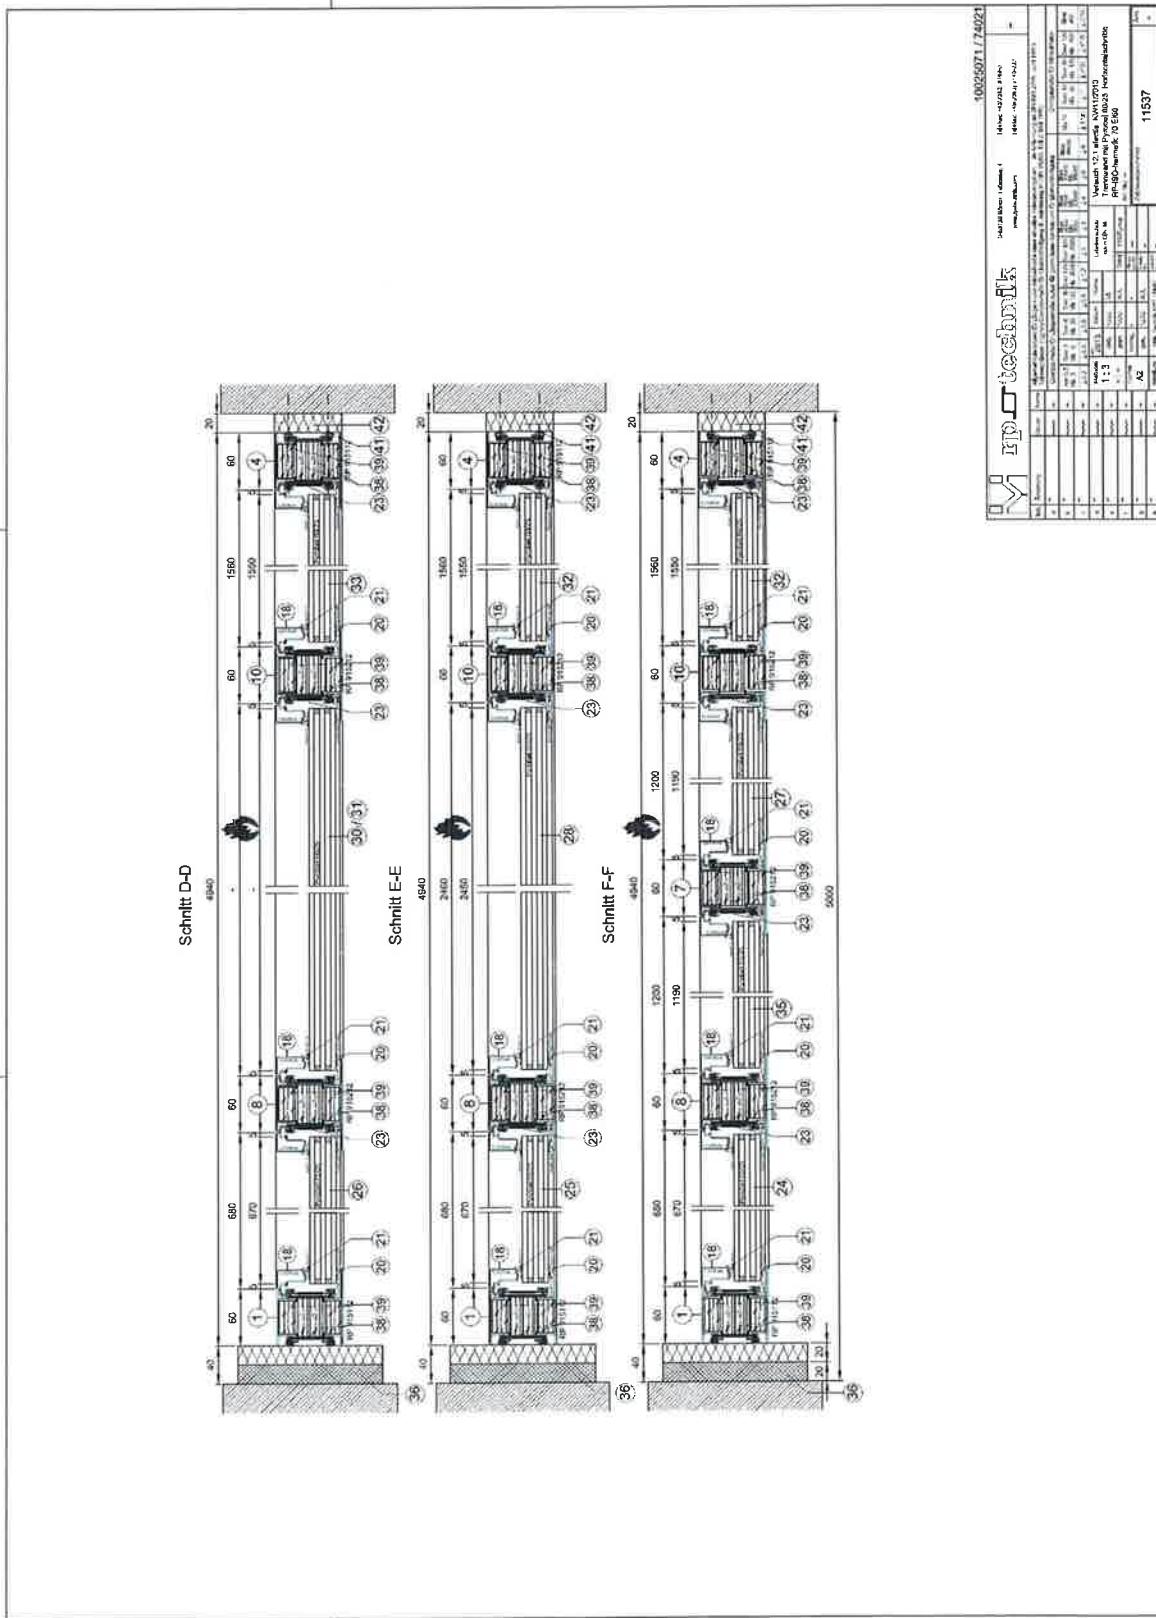
PLATE 3: HORIZONTAL SECTIONS D-D, E-E and F-F

All these profiles were mitre cut and assembled by welding. See plates nr 2 and 3.

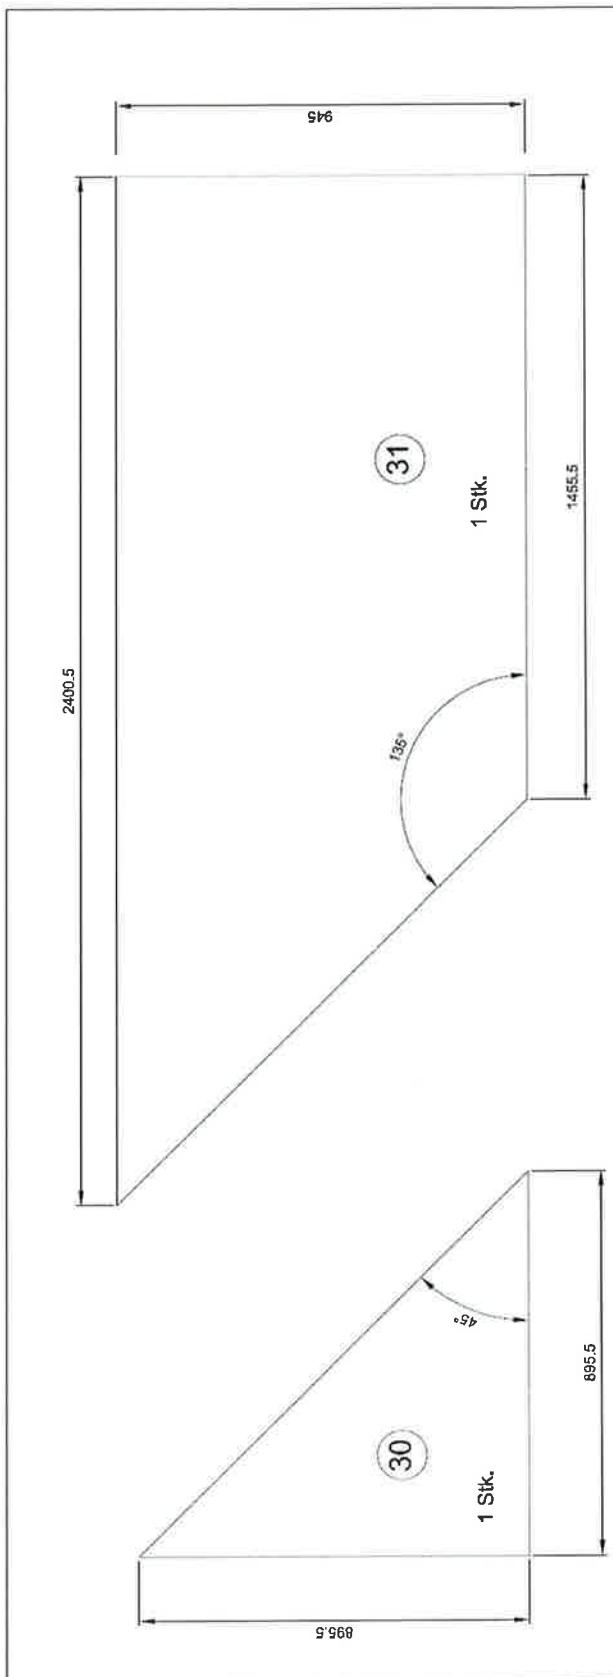
PLATE 4: DETAILS OF THE GLAZING

Reference	Dimensions (w x h) (mm)	Reference	Dimensions (w x h) (mm)
Glazing A	670 x 945	Glazing G	1550 x 925
Glazing B (triangle)	895,5 x 895,5	Glazing H	2450 x 1300
Glazing C (trapezoid)	2400,5 (biggest base) x 945 (h) x 1455,5 (smallest base)	Glazing I	1550 x 2800
Glazing D	1550 x 945	Glazing J	670 x 1430
Glazing E	670 x 2295	Glazing K	1190 x 1430
Glazing F	2450 x 925	Glazing L	1190 x 1430

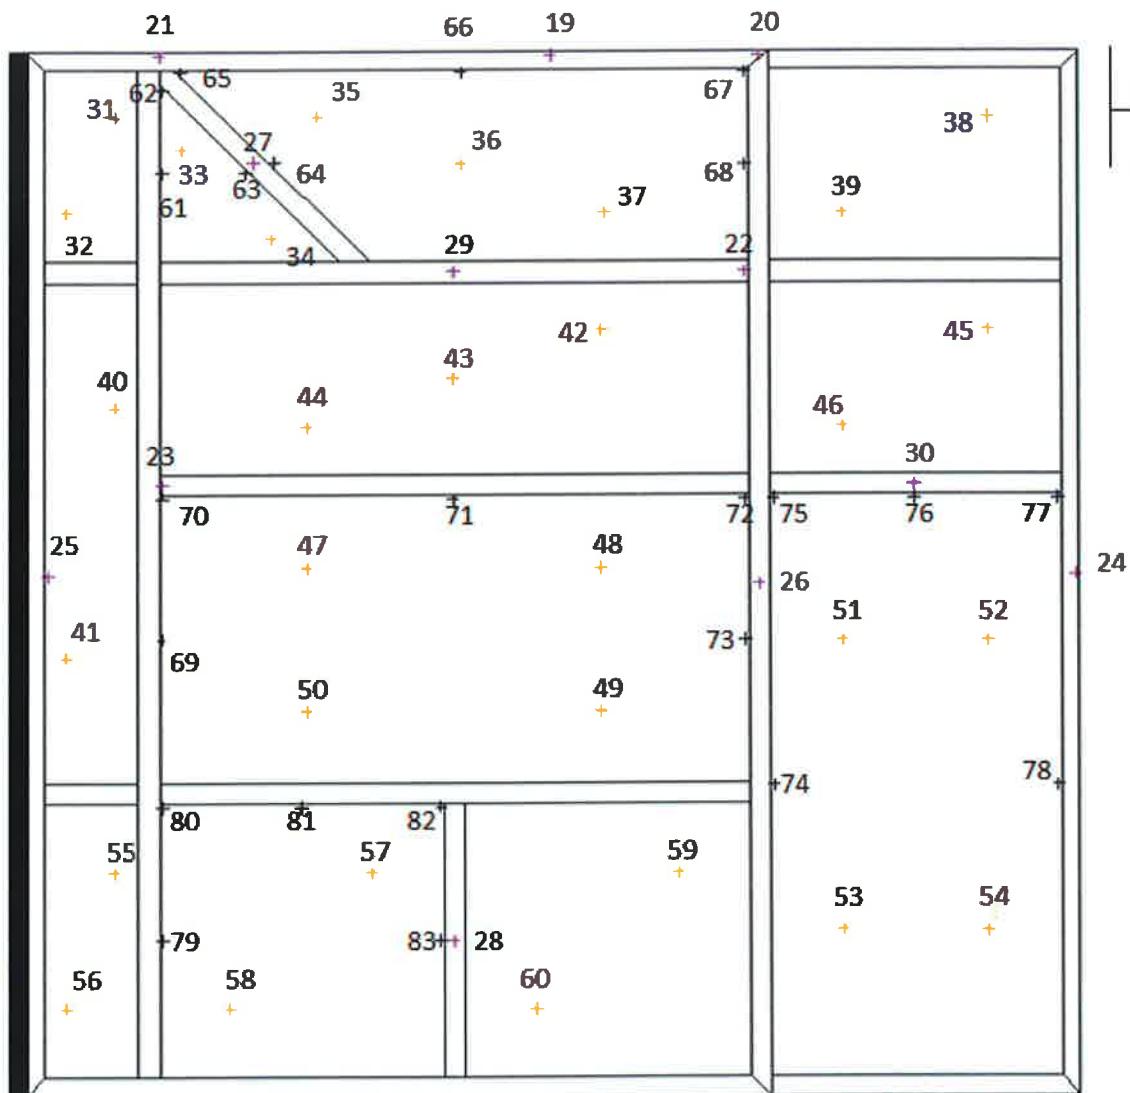
PLATE 6: SENSORS LOCATION PLAN

The locations of the sensors are shown on plates nr 6 and 7.

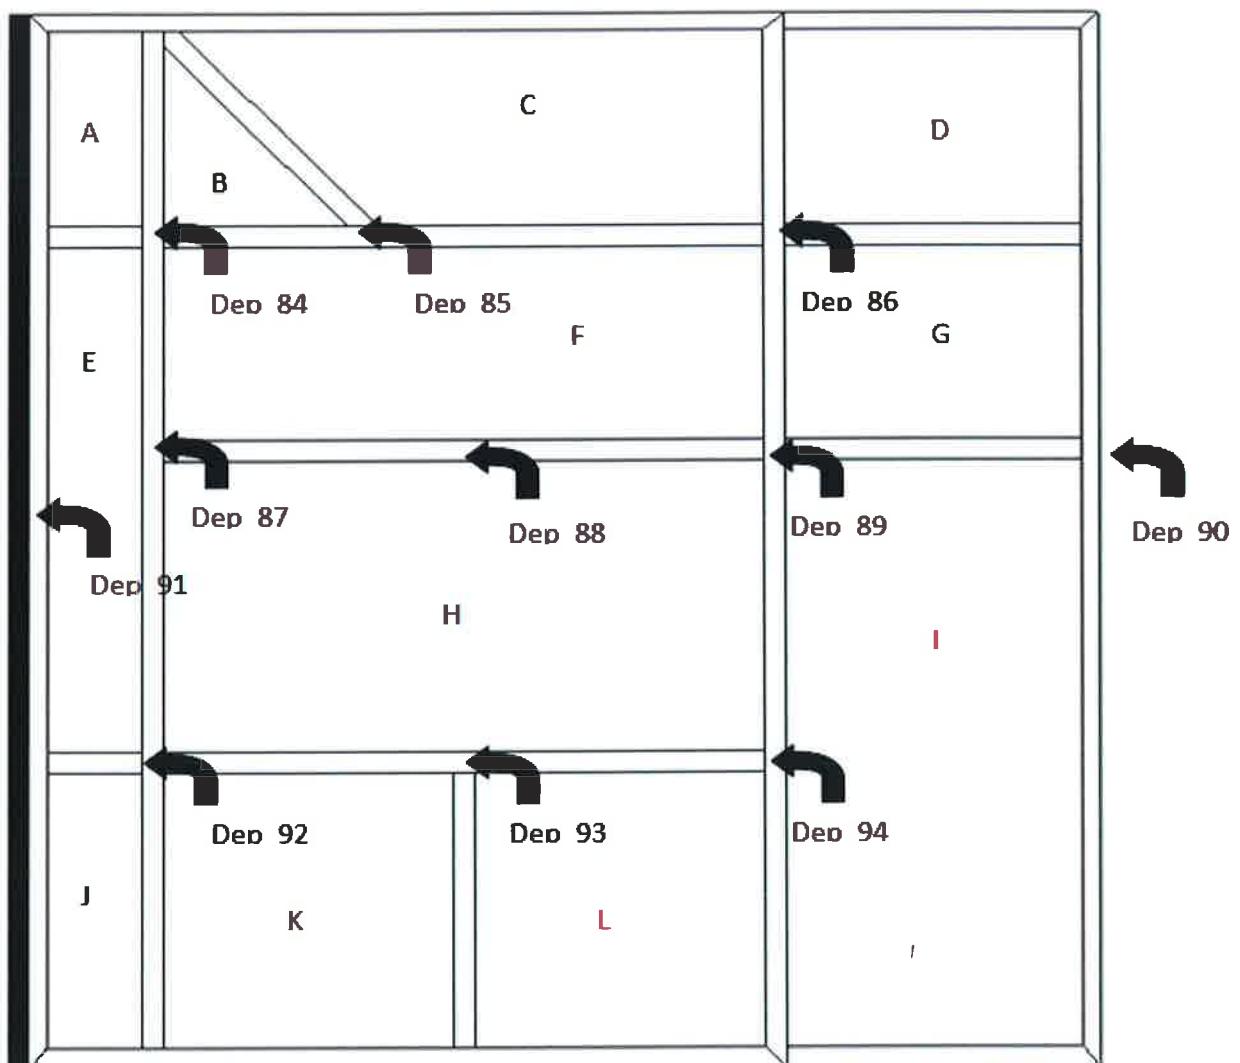
PLATE 7: SENSORS LOCATION PLAN

Note: The drawings in the plates nr 1 to 5 have been supplied by the Sponsor, checked by the test laboratory Efectis France, and are in conformity with the tested specimen. The location of the glazing is shown on plate nr 7.

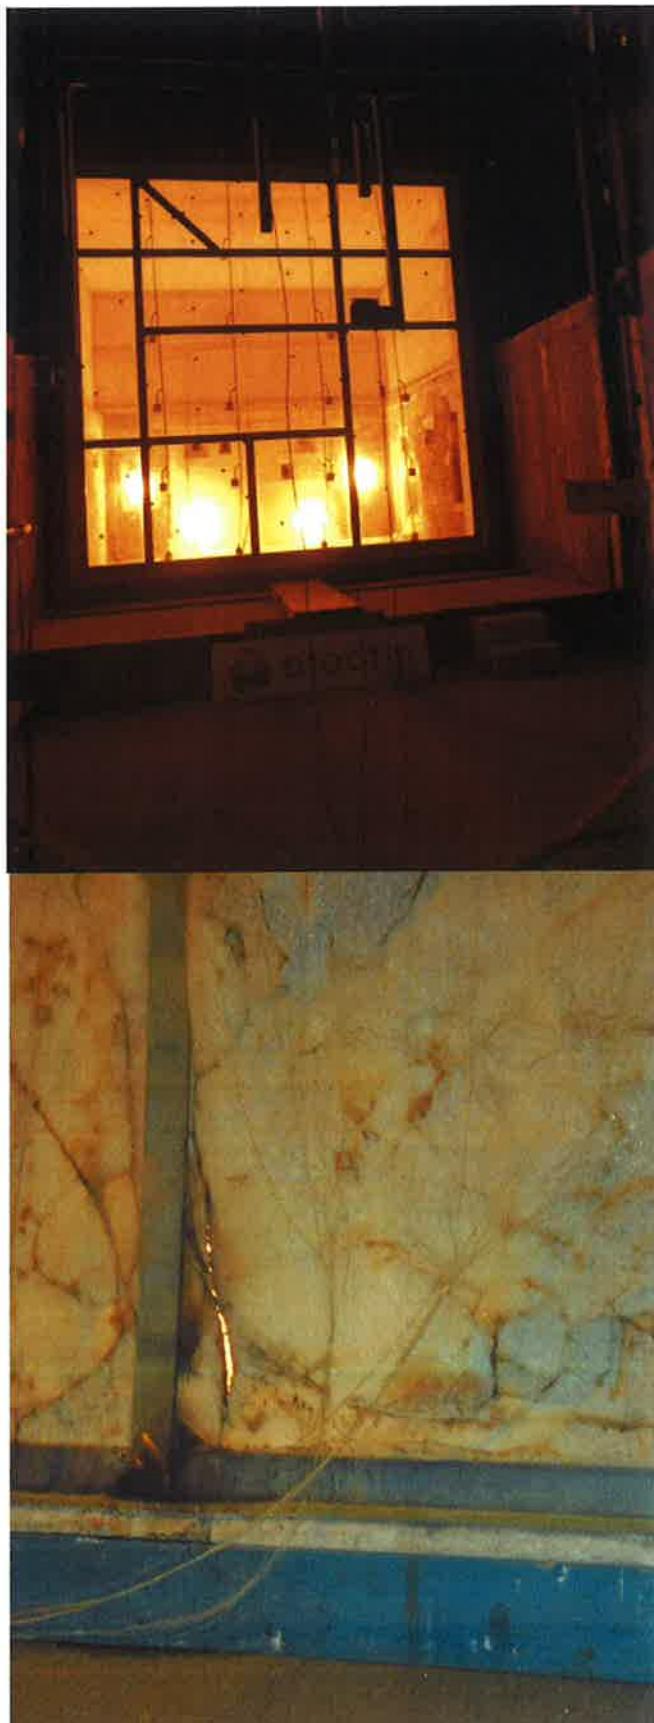
Time (min)	Observations
00	Start of the test. See photograph A.
01	Glazing J, K,L and then E to I are cracking.
01'30	Glazing A to C are cracking and the first intumescent layer of glazing E to L is developing.
02	All the glazing have cracked and the first intumescent layer of all of them has developed.
04	The first intumescent layer of glazing E to L is browning.
07	The first intumescent layer of glazing A to D is browning. The second intumescent layer starts to develop.
10	Smoke release on the cracks of glazing K and L as well as at the junctions between the two frames.
13	Important smoke release from all the junctions mullion/transom.
15	Nothing particular to report.
22	The intumescent layers are directly visible on the left peripheral side of glazing I.
25	The third intumescent layer starts to develop.
26	The intumescent layer of glazing H is pushing away the glazing on the unexposed side under thermocouple 47.

Photo A (top)	Element at the beginning of the test.
Photo B (bottom)	Opening in glazing I at the 64 th minute.

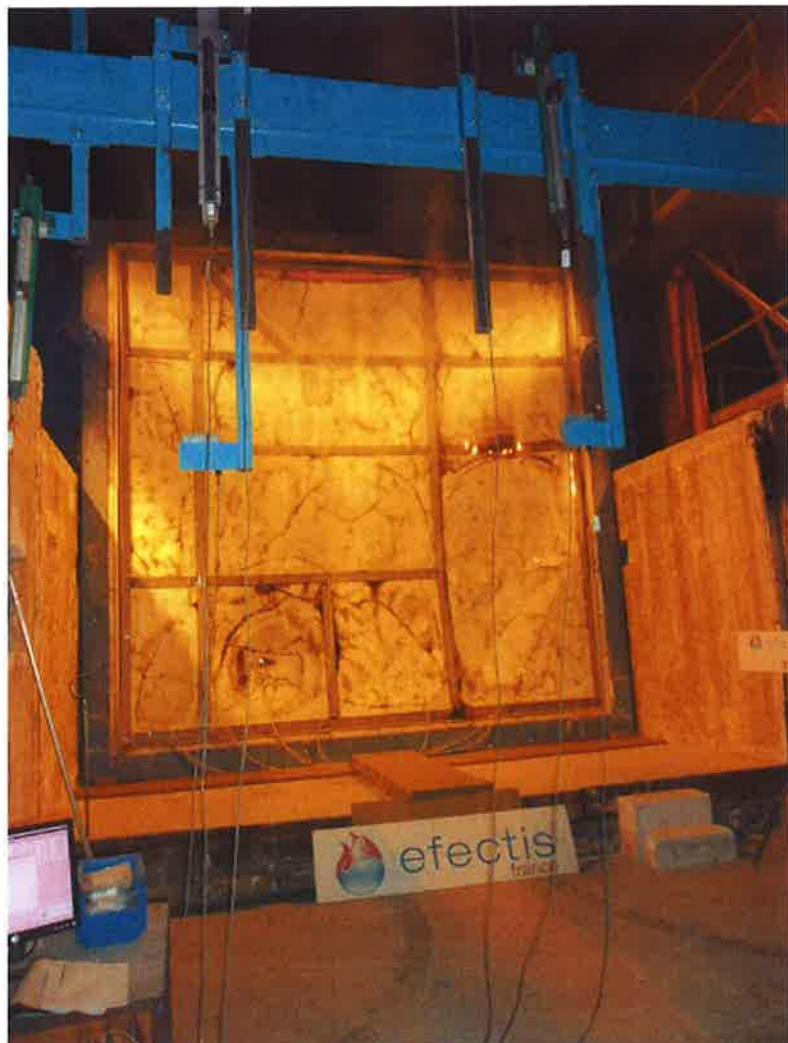
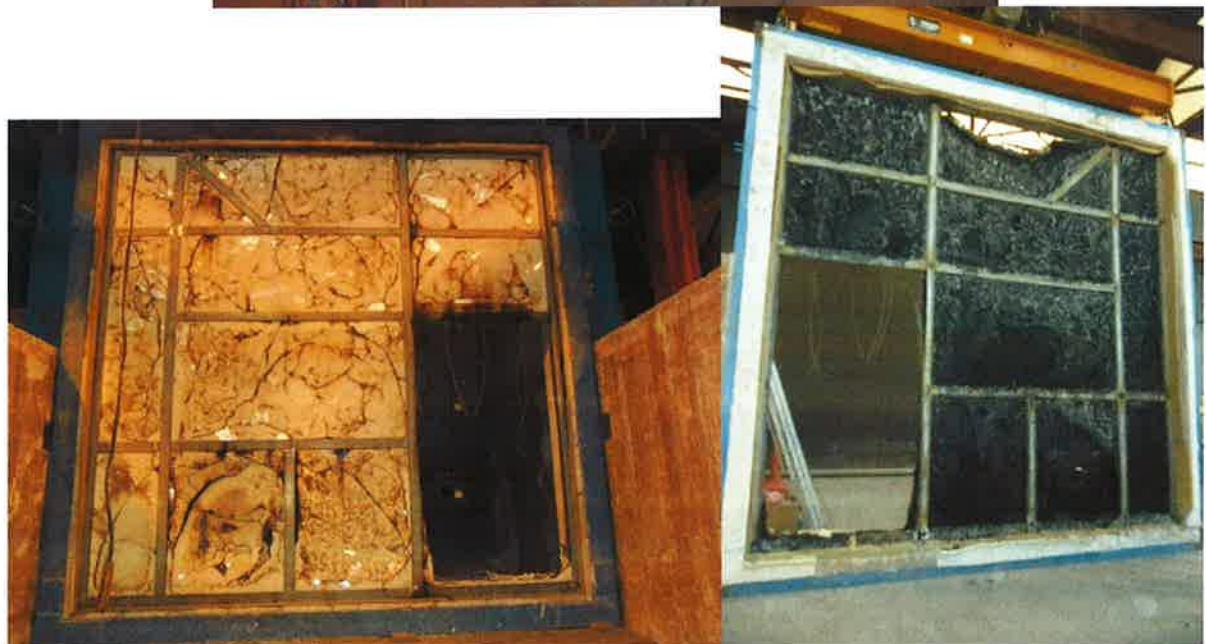
29	Incandescent spots from the crack in the left bottom corner of glazing I.
30	Nothing particular to report.
45	Nothing particular to report.
52	Cotton-wool pad test on the opening in the bottom left corner of glazing I negative.
53	Maximal temperature of thermocouple 76 placed on glazing I at mid-width of it at 15 mm from its top transom is rising over 180K compared with the initial temperature of the element. The information given by this thermocouple is only informative because placed at less than 20 mm from a discontinuity and thus the insulation criteria are always fulfilled according to norms EN 1363-1:2012 and EN 1364-1:1999.
58	Gap in the middle of glazing K: the furnace is visible but no opening is observed.
60	Nothing particular to report.
62	Ø 6 mm gap gauge test negative on the opening in the bottom left corner of glazing I.
64	Cotton-wool pad test on the opening in the bottom left corner of glazing I positive. See photo C.

65	Gap between glazing C and its top transom : no opening.
66	Sustained flaming with duration higher than 10 seconds between glazing I and its top transom as well as on the cracking made in the middle of glazing K.
67	Ø 6 mm gap gauge test estimated positive between glazing C and its top transom.
70	End of the test on request of the Sponsor. See photograph C.

See photo D. Glazing I has fallen down. No other disorder was visible.

See photo E. The glazing beads were still in place. Glazing C was still in place except the top part which bent on the unexposed side and glazing K presented cracks.

Cause of failure : **Cotton-wool pad test on the opening in the bottom left corner of glazing I positive.**

Photo C (top)	Element at the end of the test.
Photo D (bottom on the left)	Element after test and cool down on the unexposed side.
Photo E (bottom on the right)	Element after test and cool down on the exposed side.
